Société Nouvelle Centrair

SERVICE BULLETIN

No. 101-06 rev.1

SUBJECT: CHECK OF THE BONDING AND CONDITION OF THE FUSELAGE FRAMES

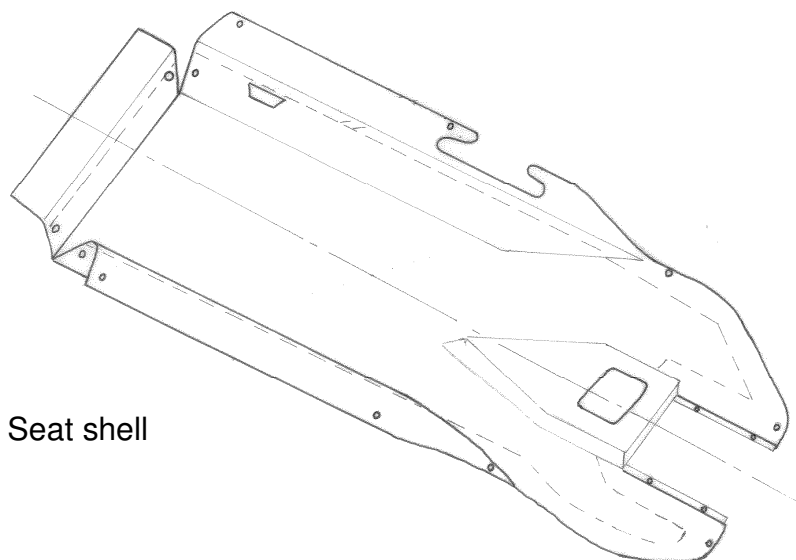
Seat shell

The frames and internal reinforcements are accessible after removal of the seat, which is attached by screws around its periphery:

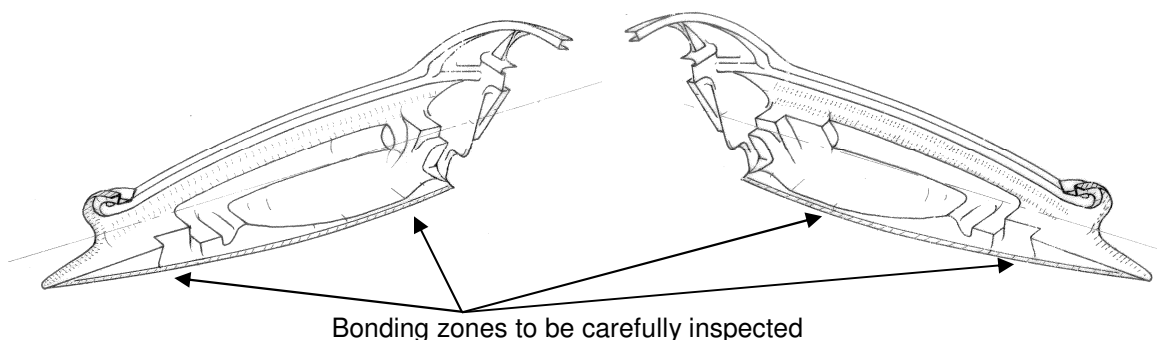
The reinforcements correspond to the items in the sketch below. They are bonded around their periphery to the skin forming the shell of the fuselage.

Right side reinforcement

Left side reinforcement

Internal reinforcements, bonding zones to the fuselage skin (if necessary, move any pneumatic hoses and electric cables to provide unrestricted access to the bonding zones).

If any damage or anomaly is found, forward a report of your findings to SN CENTRAIR and perform the mandatory and approved repairs before the next flight.

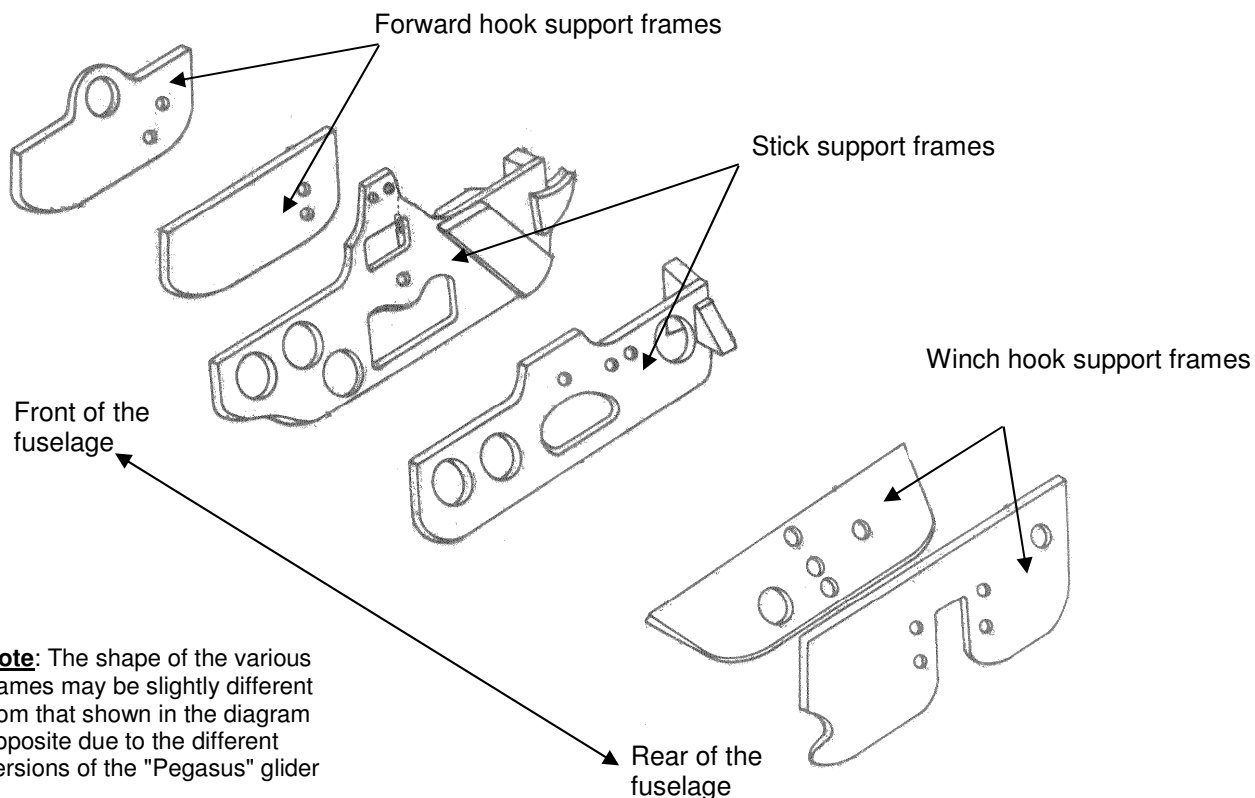
Detail of the 6 frames to be inspected in the cockpit in addition to the main landing gear support frame

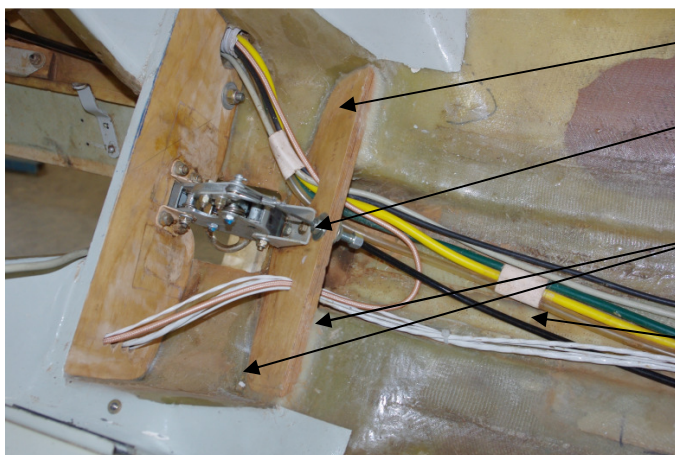
Forward winch hook frame

For gliders which use the winch hook, particular attention must be paid to the forward frame supporting the winching hook, which is highly loaded, and for which the forward hook fitting must be removed to enable proper analysis of its condition (cf. photo on page 4).

For gliders using the winch hook, careful attention must be paid to the zone of the forward hook support frame as shown in the photograph below looking in particular for any cracks on the centre-line of the frame in the zone corresponding to the hook fitting (inspection after removal of the winch hook attachment fitting on the forward frame)

Hook forward fitting

Bonding of the forward hook frame to the internal reinforcement
