BULLETIN DE SERVICE

N° 101-29

PLANEURS SN CENTRAIR
101 tous types "Pégase"

OBJECT: VERIFY CONSTRUCTION OF THE PEDALS ADJUSTMENT LOCKING TUBE

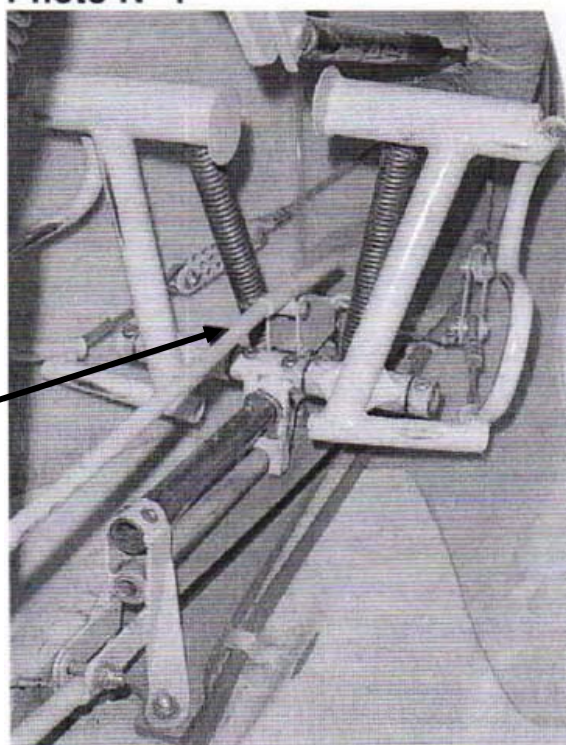
Photo N° 1

The adjustment system of the pedals consists of an articulating tube on a swing to unlock the pedals and ensure distance adjustment according to the figure of the pilot (see photo No. 1)

Articulating tube to
unlock the pedals

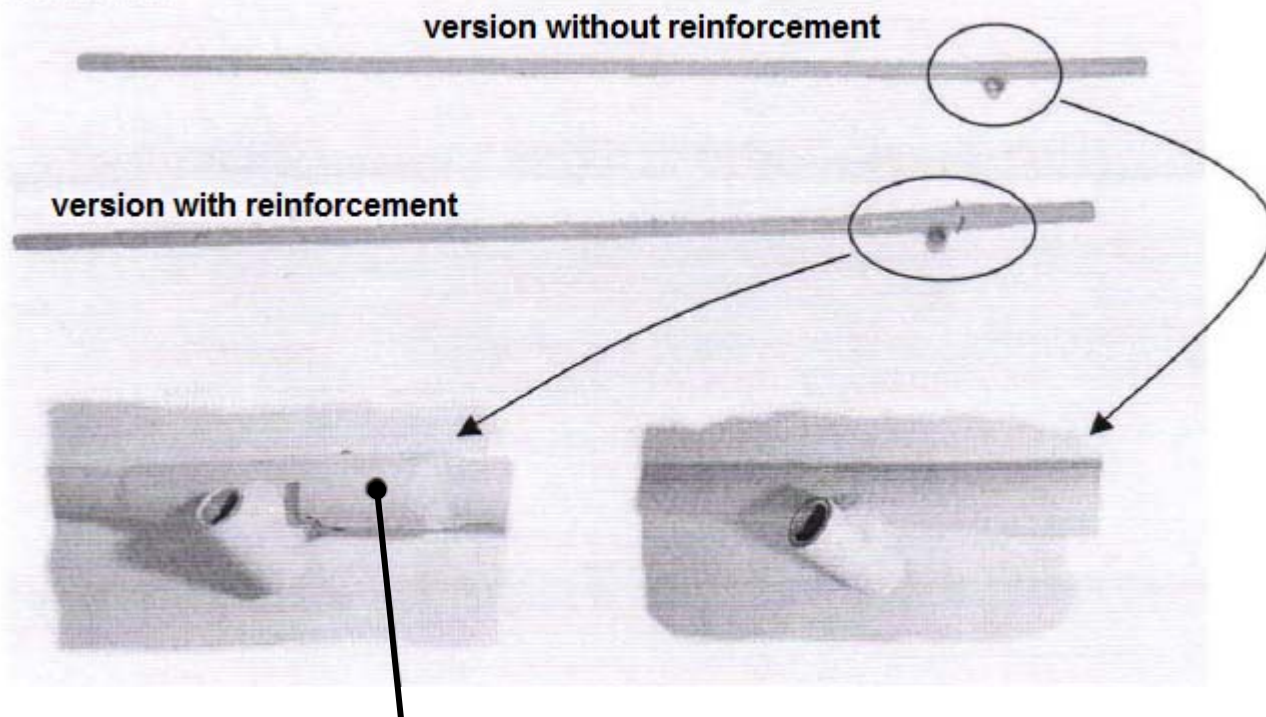
Photo N°2

The articulating tube was strengthened in 1984 to avoid possible operational matters. The gliders manufactured before this evolution weren't systematically retrofitted.

The differences between the 2 versions are explained in the picture No. 2 here after.

Presence of a reinforced tube at the height of the pivot point for the enhanced version

Having recently been informed of the rupture of such an old type of articulating tube, it is confirmed that the reinforcement of this piece was justified and the systematic replacement of this old, non reinforced version, is necessary.

It is therefore requested, within 1 month, to check the version of adjustment tube which is installed in your glider (visual inspection without removal of parts of the glider).

In case of a reinforced tube version (e.g. photo No. 2) you don't have to perform supplemental actions.

If finding a non-reinforced tube version (e.g. photo No. 2), it is asked, before the next annual inspection, to perform a replacement by part ref. \$ Y186A. In case of observing damage on the locking tube the replacement must be done before next flight.
