Société Nouvelle Centrair

SERVICE BULLETIN N° 101-33

SN CENTRAIR 101 gliders
all "Pegasus" types

SUBJECT: TO ENSURE CORRECT INSTALLATION OF THE AIRBRAKE PLATES ON THE WING.

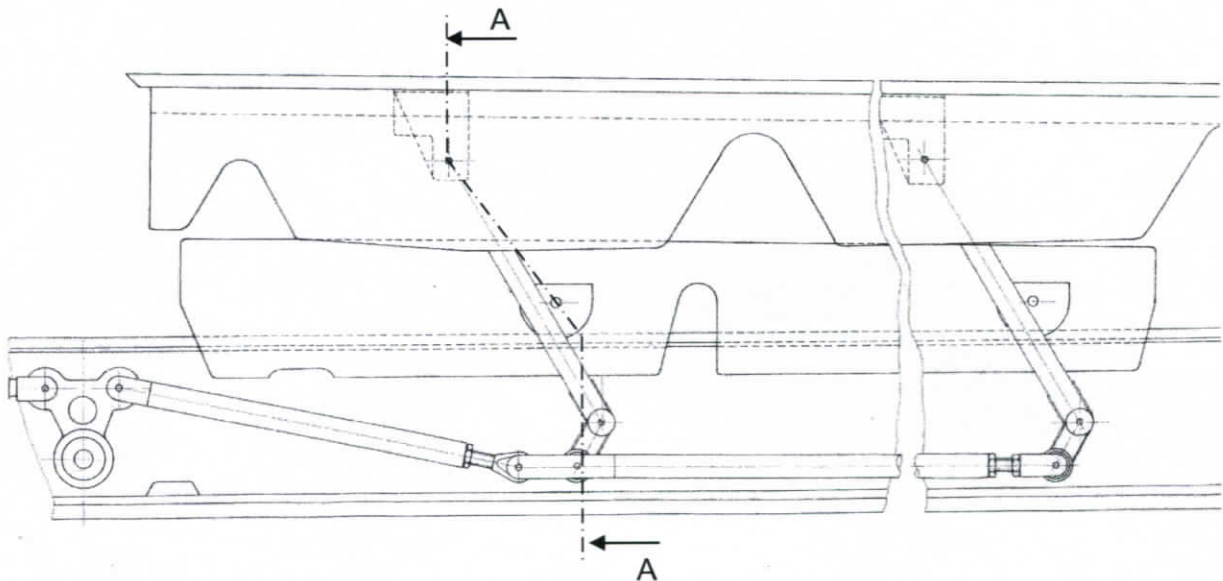
Sketch No. 1: Airbrake linkage in the wing (shown with the airbrake plates partly extended)

The airbrake plates are mounted on arms hinged from the wing (see sketches Nos. 1 and 2 on the following pages).

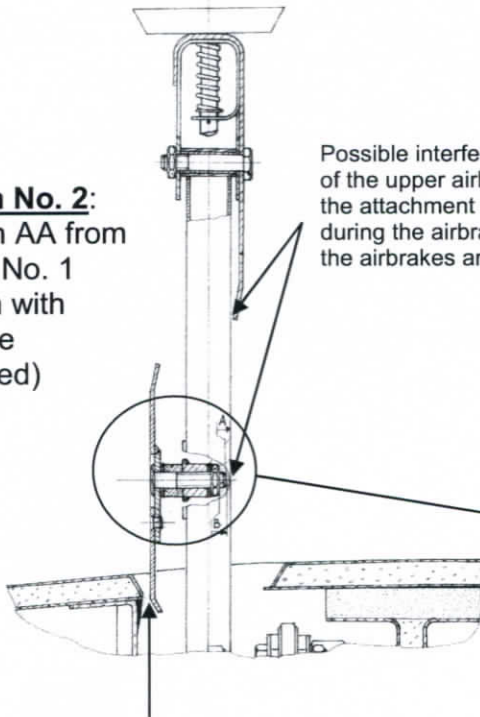
Sketch No. 2:
Section AA from
sketch No. 1
(shown with
airbrake
extended)

Clearance between the
wing structure and the
lower airbrake plate

Possible interference between the bottom
of the upper airbrake plate and the end of
the attachment bolt of the lower plate
during the airbrake retraction motion (when
the airbrakes are half retracted)

In the event of inadequate clearance, check the tightening of the 2 attachment nuts of the lower plate (cf. Sketch No. 3) and inspect for any possible distortion of the lower airbrake plate. Correct any defects found.

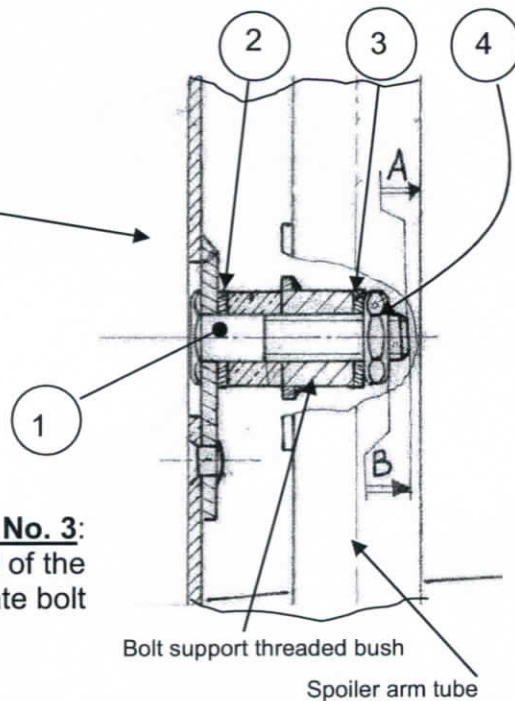
Sketch No. 3:
Installation detail of the
lower airbrake plate bolt

Note: The tightening of bolt, Item 1, must be moderate.
It must not cause excessive friction in the pivoting
motion of the airbrake arms.
It must however be sufficient to ensure proper
guidance of the airbrake plate (it should not be able to
incline relative to the spoiler airbrake arm).
The locknut, Item. 4 (installed with Loctite "Medium
threadlock" ref. 243) is intended to lock bolt, Item 1,
in position.

In the event of non-compliance with these values, the glider must be reconditioned for flight by ensuring compliance of the installation of the bolts for the lower airbrake plates with sketch No. 3.

The total length of the bolts, Item 1 in sketch No. 3, under their heads, must be 26.5mm. If the length of the bolts fitted to the glider is different, they must be replaced with bolts part number SY856A.

Washer, Item 2 (part No. SN CENTRAIR 400126) in sketch No. 3 is optional and is intended to modify the clearance between the lower airbrake plate and the structure of the wing as well as the free length of the bolt behind the locknut, Item No. 4 (see sketch No. 3). It may be deleted if necessary to modify the above clearances.

It may be necessary to slightly chamfer washer No. 3 (part No. SN CENTRAIR 400126) to avoid any possible interference between this washer and the weld of the bolt support threaded bush with the airbrake arm tube

Nut No. 4 must be replaced with a new nut each time it is removed (nut part No. SN CENTRAIR 400030). It must be installed using Loctite "Medium threadlock" ref. 243.

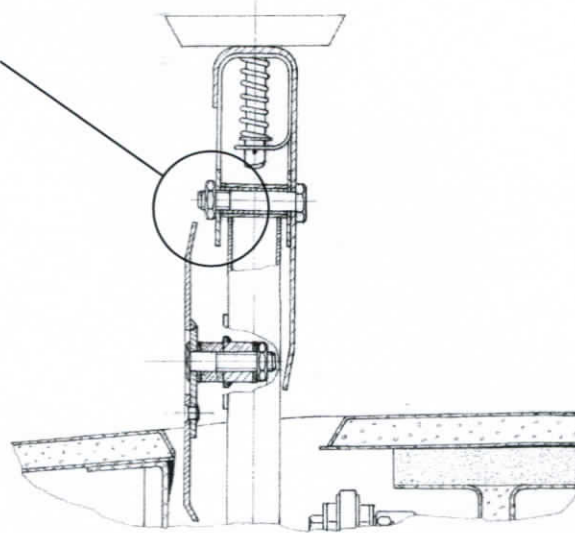
Sketch No. 4: Section AA from sketch No. 1 (shown with the airbrake 2/3 retracted)

Possible interference between the top of the lower airbrake plate and the end of the attachment bolt of the upper plate during the airbrake retraction motion (when the airbrakes are 2/3 retracted)

In the event of inadequate clearance, check the tightening of the 2 attachment nuts of the lower plate (cf. Sketch No. 3) and inspect for any possible distortion of the lower airbrake plate. Correct any defects found.
