BULLETIN de

N° 101-4

Planeur CENTRAIR 101, 101A
101AP, 101P

Objet: Mandatory inspection of the upper rudder hinge.

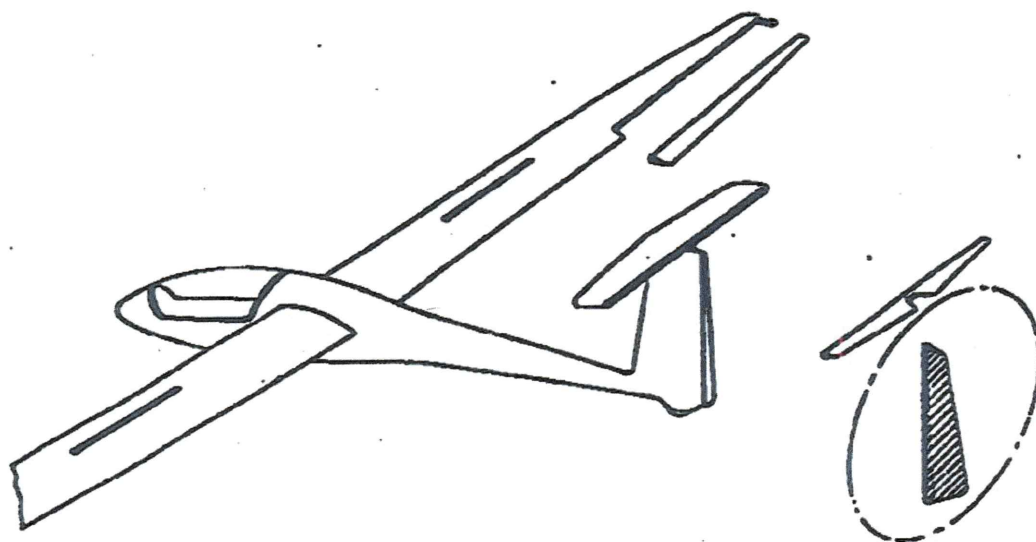
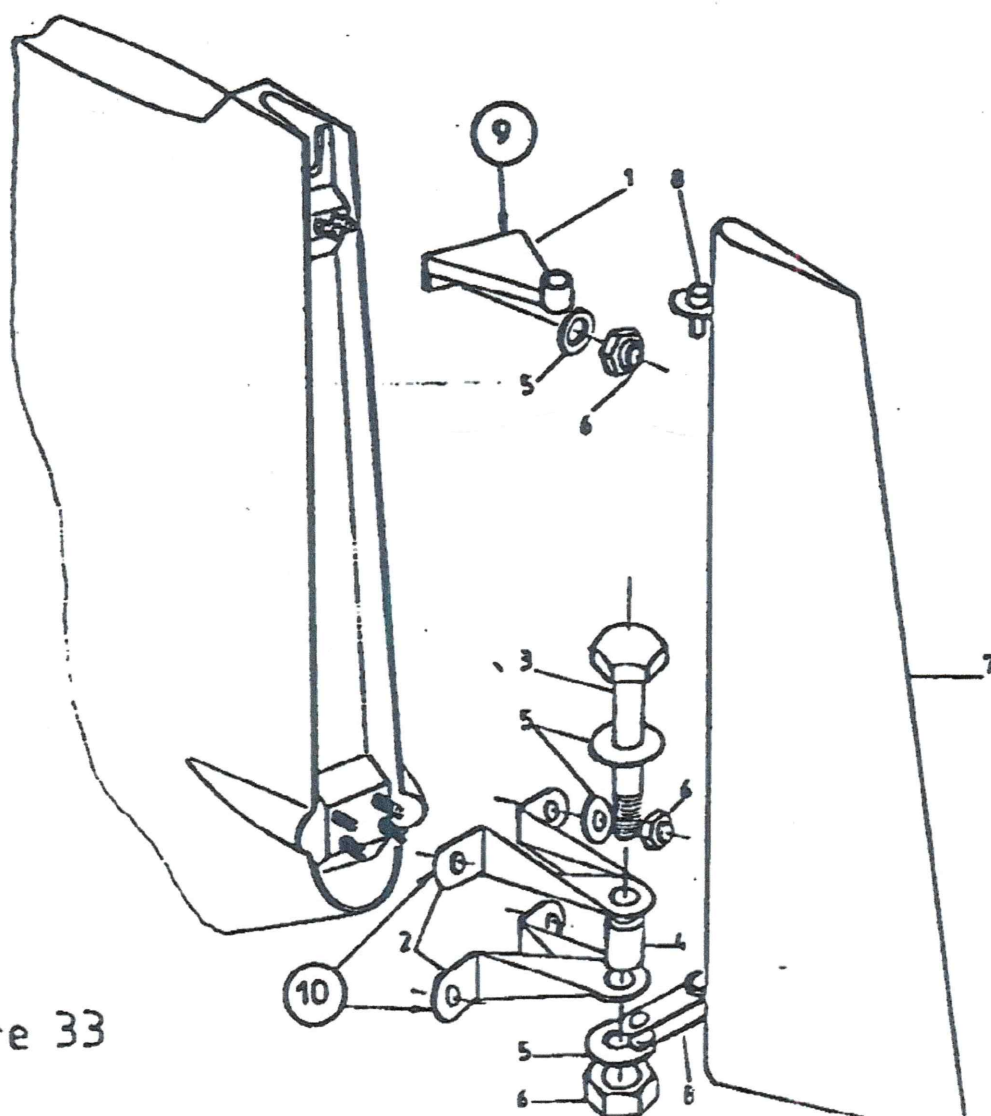
Figure 33

Following the discovery of two failures of the upper rudder hinge pivot, it is imperative to immediately check the upper rudder hinge pivot by disassembling the rudder :

1. Check pivot weld by pushing down on the pivot
2. Check the pivot for signs of seizure

1. Remove the rudder control cables (rep.15 fig.22)
2. Remove the bottom rudder hinge retaining bolt (rep.3 fig.33)
3. Pull the rudder back slightly (to clear the bottom rudder hinge) then lift rudder to disengage it from the vertical fin.

In the case of a failed pivot or seized pivot the aircraft must be grounded until repair kit number one (1) is installed. This repair kit consisting of upgraded parts must be ordered from the manufacturer CENTRAIR immediately.
